Salt Preservation

A Salty Heritage

Licking the problem of Poland's melting treasures

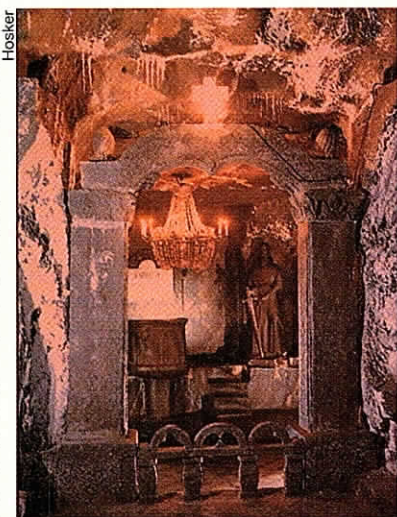
Stalactites mar St. Anthony's ceiling.

The problem was aggravated in recent decades, Kozłowski says, when commercial mining at Wieliczka was phased out in favor of an increasingly more lucrative activity—tourism. From April through October, the humid air accompanying elevator loads of sightseers, along with the increased ventilation air, quickly condenses onto the cooler salt surfaces in the upper regions of the mine. A thin layer of water forms, at times actually dripping. This seems to explain the salt stalactites on the ceiling of St. Anthony's Chapel.
